Hydraulics

HOWTO...

Identify and cure piping leaks

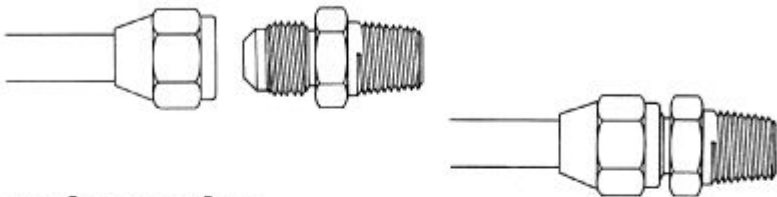
SAE 37° Flare Connection (SAE J514)

how it works:

This connection seals on the two mating 37° seats.

Most of the leaks on this connection are due to lack of tightening or human error. You can't tell if the nut has been tightened by just looking at the connection. If it is more than finger tight, you can't tell from observation how much. Torque wrenches are good only when they are used. You must rely on the user to be sure torque wrenches are used on all joints. The user must depend on his memory to know if he has tightened all of the joints.

Here are steps for an excellent method of tightening. Anyone can tell if the joint was tightened and how much.

1. Tighten the nut by hand until it bottoms the seats.
2. Using a marker, draw a line lengthwise on the nut and extend it onto the adapter.
3. Using a wrench, rotate the nut to tighten. Turn the nut the amount shown in the chart on the next page.

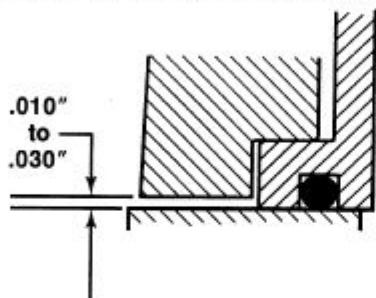
SAE 4-Bolt Split Flange Connection (SAE J518 Codes 61 and 62)

how it works:

The SAE 4-bolt split flange connection is a face seal. The flanged head which contains an O-Ring seal must fit squarely against the mating surface and be held there with even tension on all bolts. The flanged head protrudes past the split flange clamps by .010 to .030 inch. This is to ensure that the flanged head will make contact with the mating accessory surface, compressing the O-Ring to form the seal.

This connection is sensitive to installation errors and bolt torquing. Because of the flanged head protrusion and the flange clamp overhang, the flanges tend to tip up in a seesaw fashion when the bolts are tightened on one end. This pulls the opposite end of the flange away from the flanged head and, when hydraulic pressure is applied to the line, pushes the flanged head into a cocked position allowing seal extrusion.

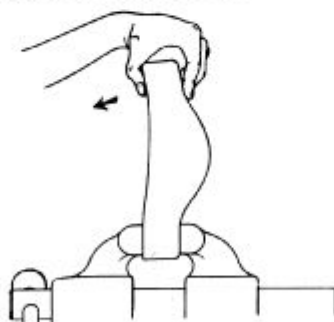
Note: Air wrenches tend to cause flange tipping.

Bending of bolts and flanges soaks up much of the torque values.

When excessive torque is applied to the bolts, the flanges often bend down until they bottom on the accessory. This also causes the bolts to bend outward.

Bending of the flanges and bolts tend to lift the flange off the shoulder in the center area between the long spacing of the bolts.

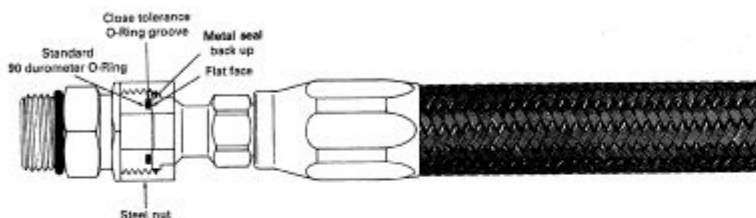
O-Ring Face Seal Connection (SAE J1453)

Eaton's O-Ring Face Seal fittings and adapters are flat faced O-Ring seal connections that provide an excellent solution for leakage problems. These connections meet SAE J1453 performance requirements and are designed to handle working pressures up to 6000 psi. In order for this connection to virtually eliminate piping leaks, care must be taken to avoid the following problems, which may cause leakage.

2. No O-Ring in the groove Make sure that the O-Ring does not fall out of the male end before the connection is made. Proper lubrication will help.
3. Improper O-Ring size Although the O-ring Face Seal connection uses a standard size O-Ring, it is not the same size as those used on O-Ring boss or split flange fittings. It is critical that the correct O-Ring is used. The proper dash sizes and dimensions are listed on the chart below.

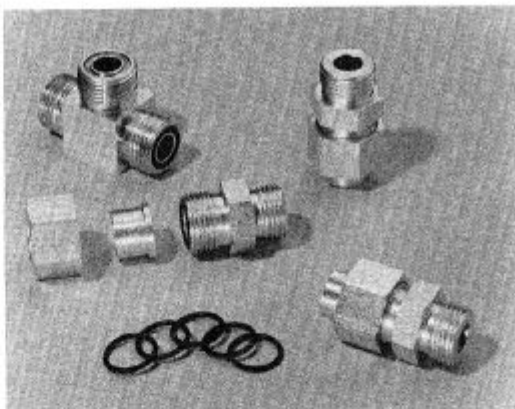
Eaton O-Ring Face Seal connections

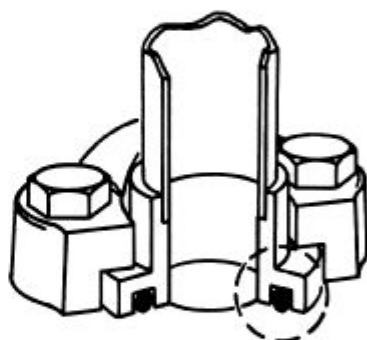
SAE 4-bolt split flange connection

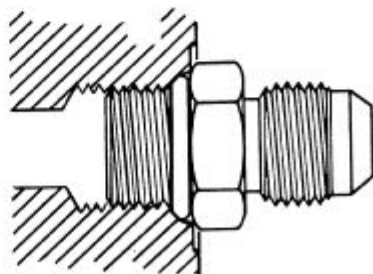
SAE O-Ring boss connection
